Technical Volume 2

“Safety assessment”

IAEA

The Fukushima Daiichi Accident
Technical Volume 2, Section 2.1

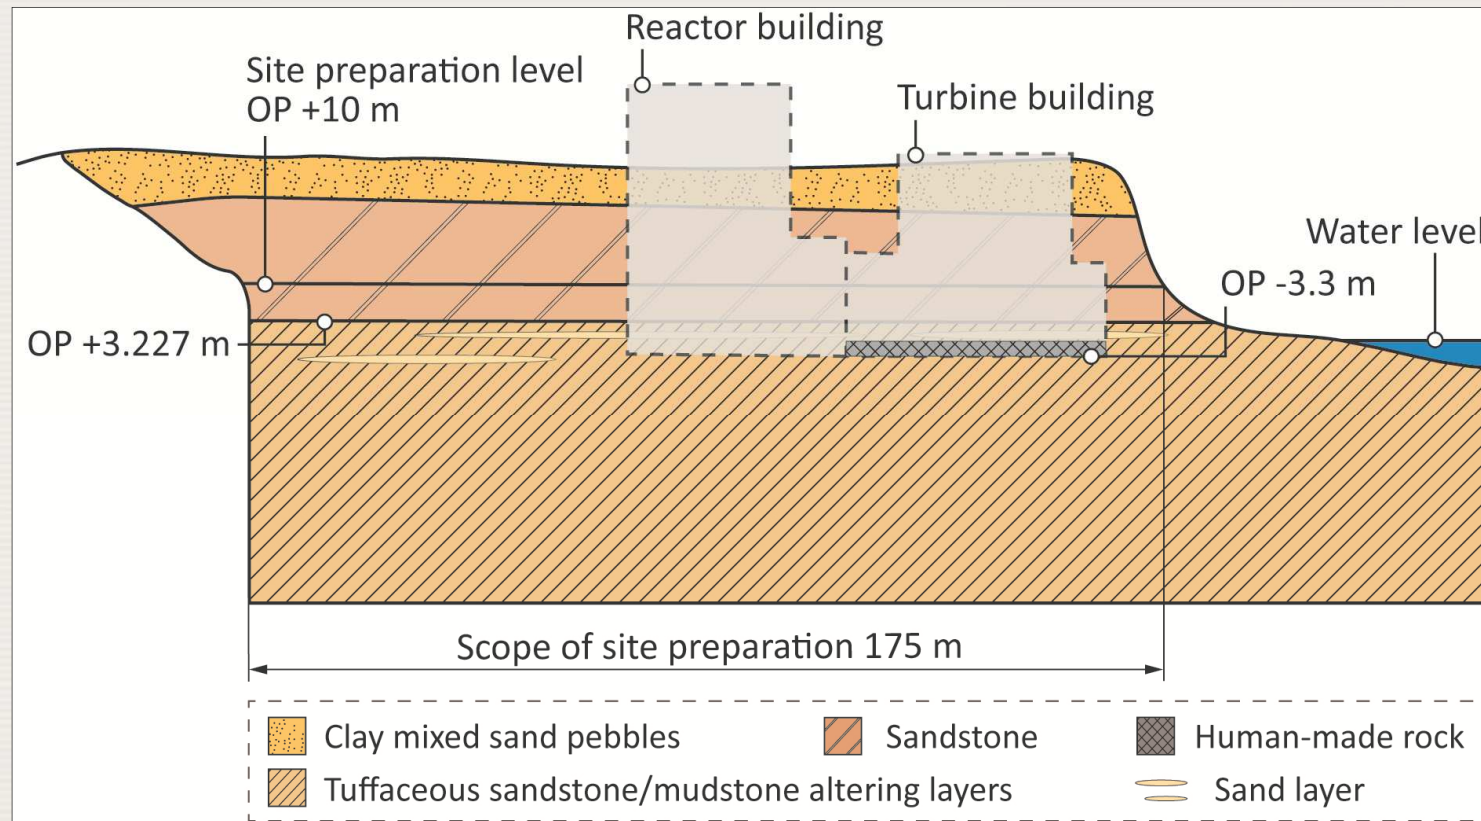
Excavation Plan

- Approximately **25 meters of soil and rock removed** as part of original siting plan
 - Based on design basis flooding height of O.P. + 3.122 meters (revised to O.P. + 6.1 meters)
- No apparent damage caused by the earthquake to safety related structures, systems and components
- The tsunami far **exceeded the design basis** and caused major damage to power and core cooling systems
- Major conclusion of assessment was that the treatment of external hazards for the Fukushima Daiichi NPP site was **not fully in line with international practice**

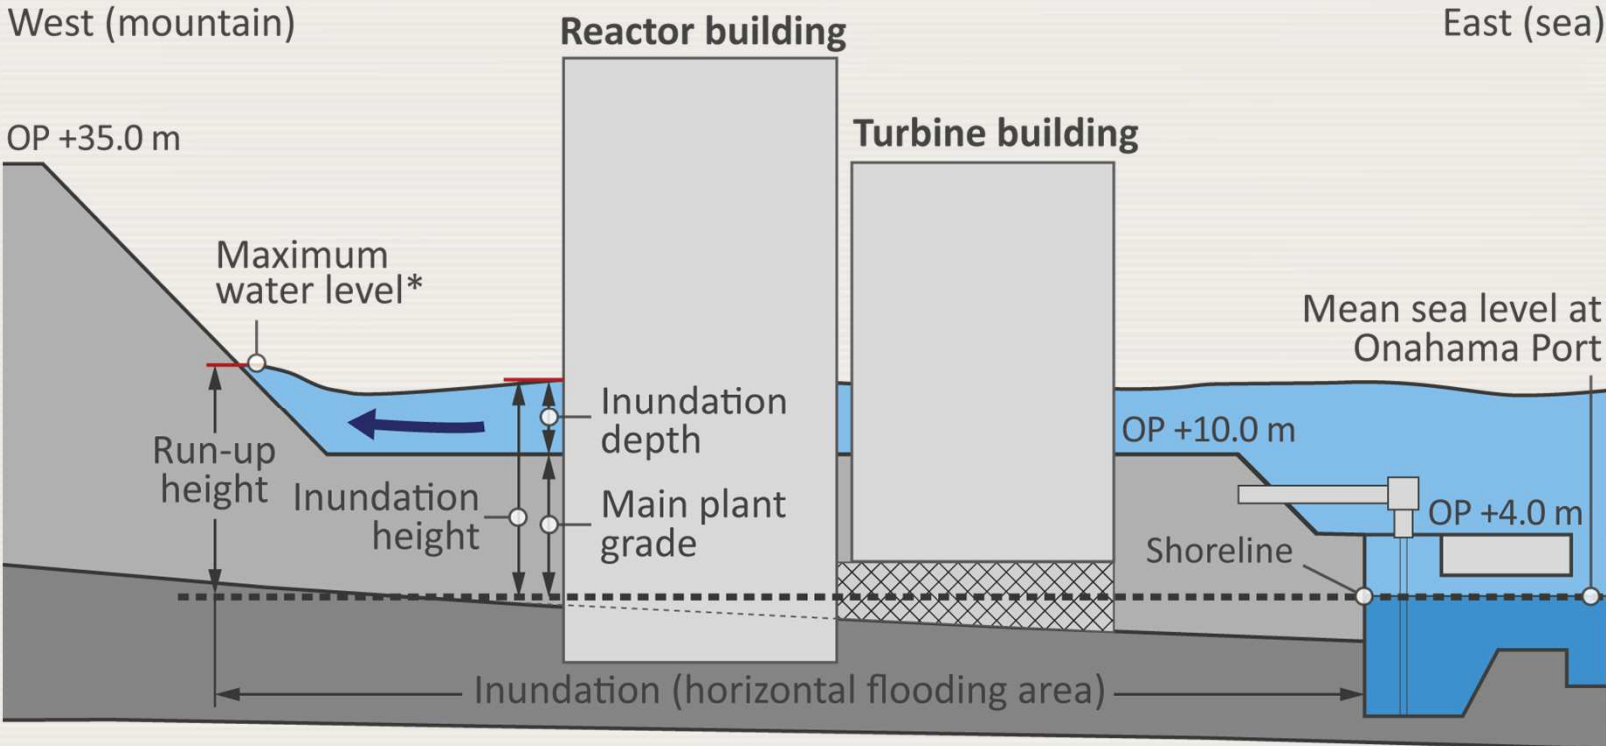
Tsunami parameters at the shoreline

*The maximum water level can be at the maximum inundation, the shoreline or between these points.

- External hazards assessment and regulatory requirements need to be **periodically re-assessed and updated**
- Decisions derived from external hazards assessments need to be appropriately conservative to **account for uncertainties**
- When faced with hazards predictions that challenge current assumptions **interim corrective actions** need to be taken
- **Multi-unit and multi-site accidents** need to be assessed
