Technical Volume 2

“Safety assessment”

IAEA

The Fukushima Daiichi Accident
Technical Volume 2, Section 2.1

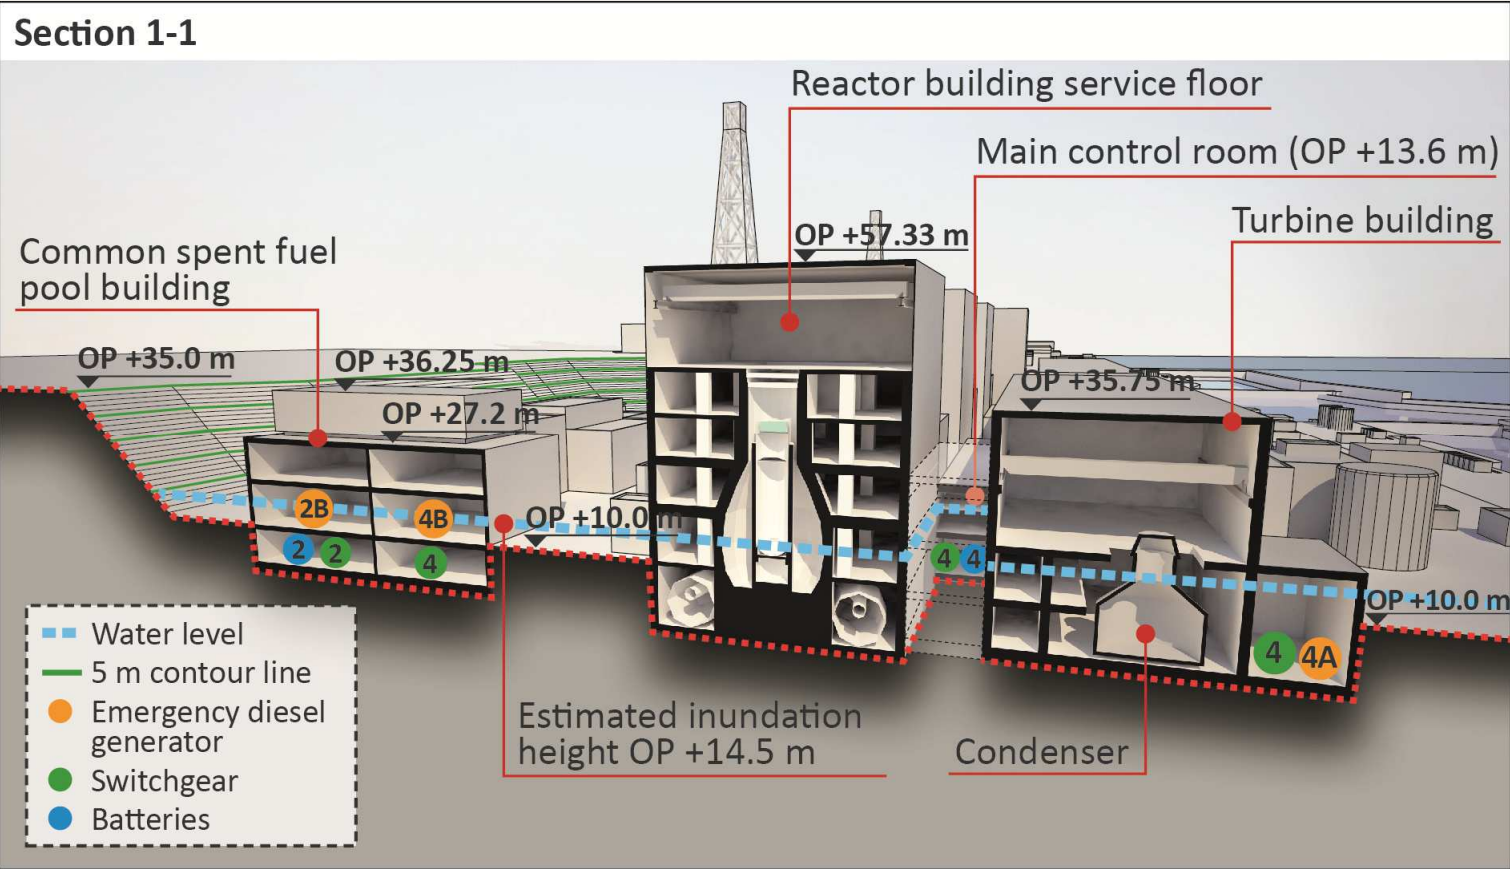
Final building layout

- Approximately **25 meters of soil and rock removed** as part of original siting plan
 - Based on design basis flooding height of O.P. + 3.122 meters (revised to O.P. + 6.1 meters)
- No apparent damage caused by the earthquake to safety related structures, systems and components
- The tsunami far **exceeded the design basis** and caused major damage to power and core cooling systems
- Major conclusion of assessment was that the treatment of external hazards for the Fukushima Daiichi NPP site was **not fully in line with international practice**

- External hazards assessment and regulatory requirements need to be **periodically re-assessed and updated**
- Decisions derived from external hazards assessments need to be appropriately conservative to **account for uncertainties**
- When faced with hazards predictions that challenge current assumptions **interim corrective actions** need to be taken
- **Multi-unit and multi-site accidents** need to be assessed

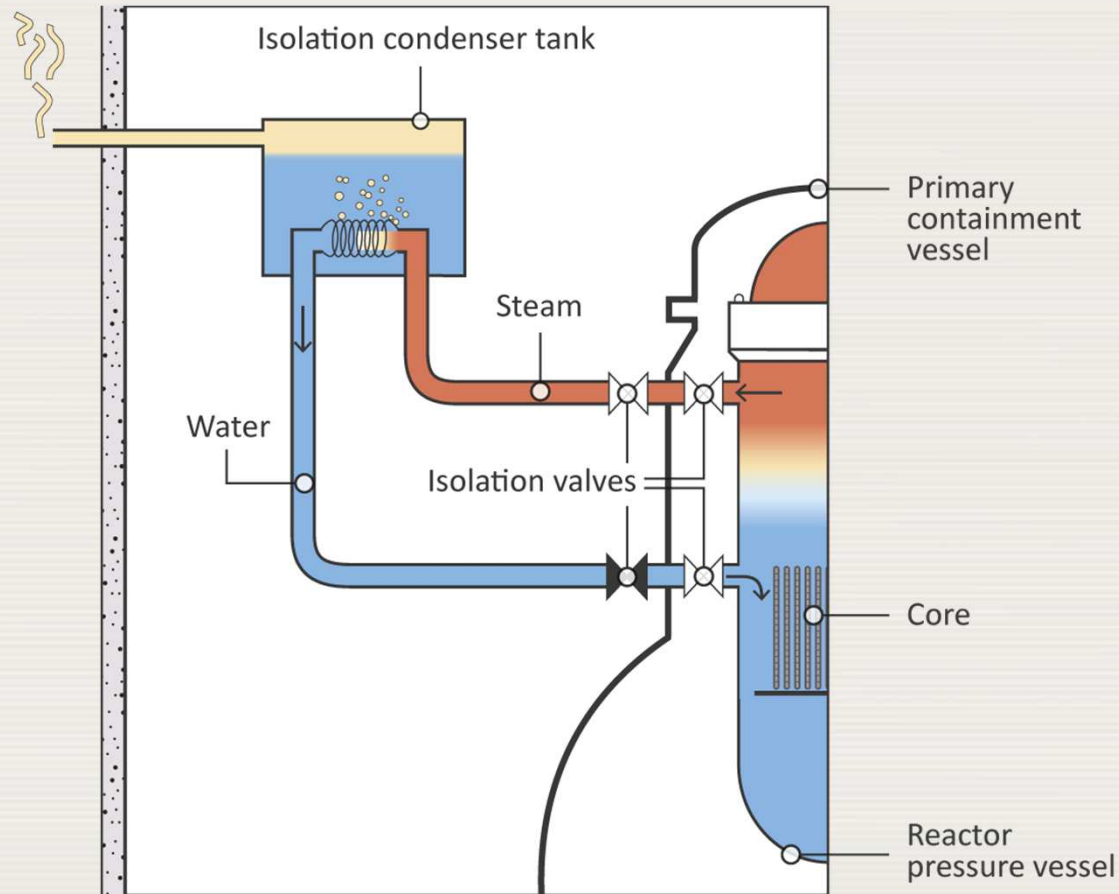
- All indications are that there **was no return to power** at any of the six reactors on the site

- At various times throughout the three days following the initial earthquake the ability to cool the core was lost **due to the flooding induced common cause failure**
- Core cooling was successfully re-established for Units 5 and 6

- Indications are that the containments for Units 1, 2 and 3 were damaged because of the **loss of power, cooling capability and challenges with venting**

- **Provisions** need to be made to ensure the maintenance of **fundamental safety functions** including **alternative provisions for removing decay heat**
- **Training** on managing severe plant conditions needs to be provided and it should consider extreme environmental conditions
- Defence in Depth Level 4 provisions should be **independent** of Level 3
- **Critical instrumentation** needs to be identified and protected for severe conditions
- **Interconnections** between units should be designed to **prevent accident migration**

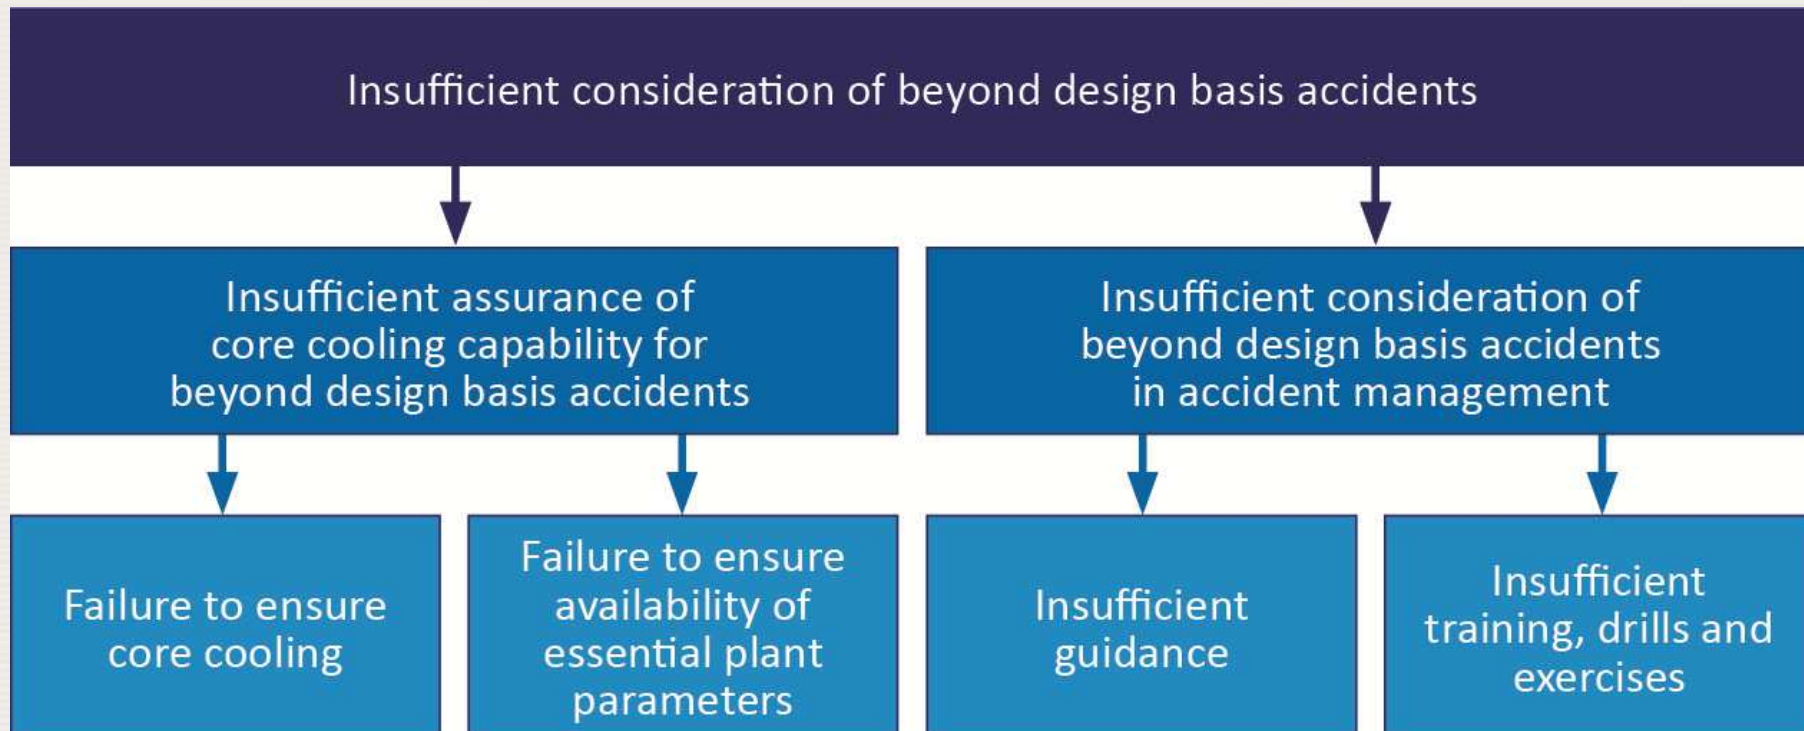
- Limited scope PSA did not identify plant vulnerability to flooding
- PSA results for Fukushima Daiichi NPPs were several orders of magnitude lower than similar plants in other Member States

- Incomplete knowledge of potential accident sequences and consequences led to inadequate procedural guidance
- Operators were forced to develop response strategies during the accident which led to considerable and consequential delays

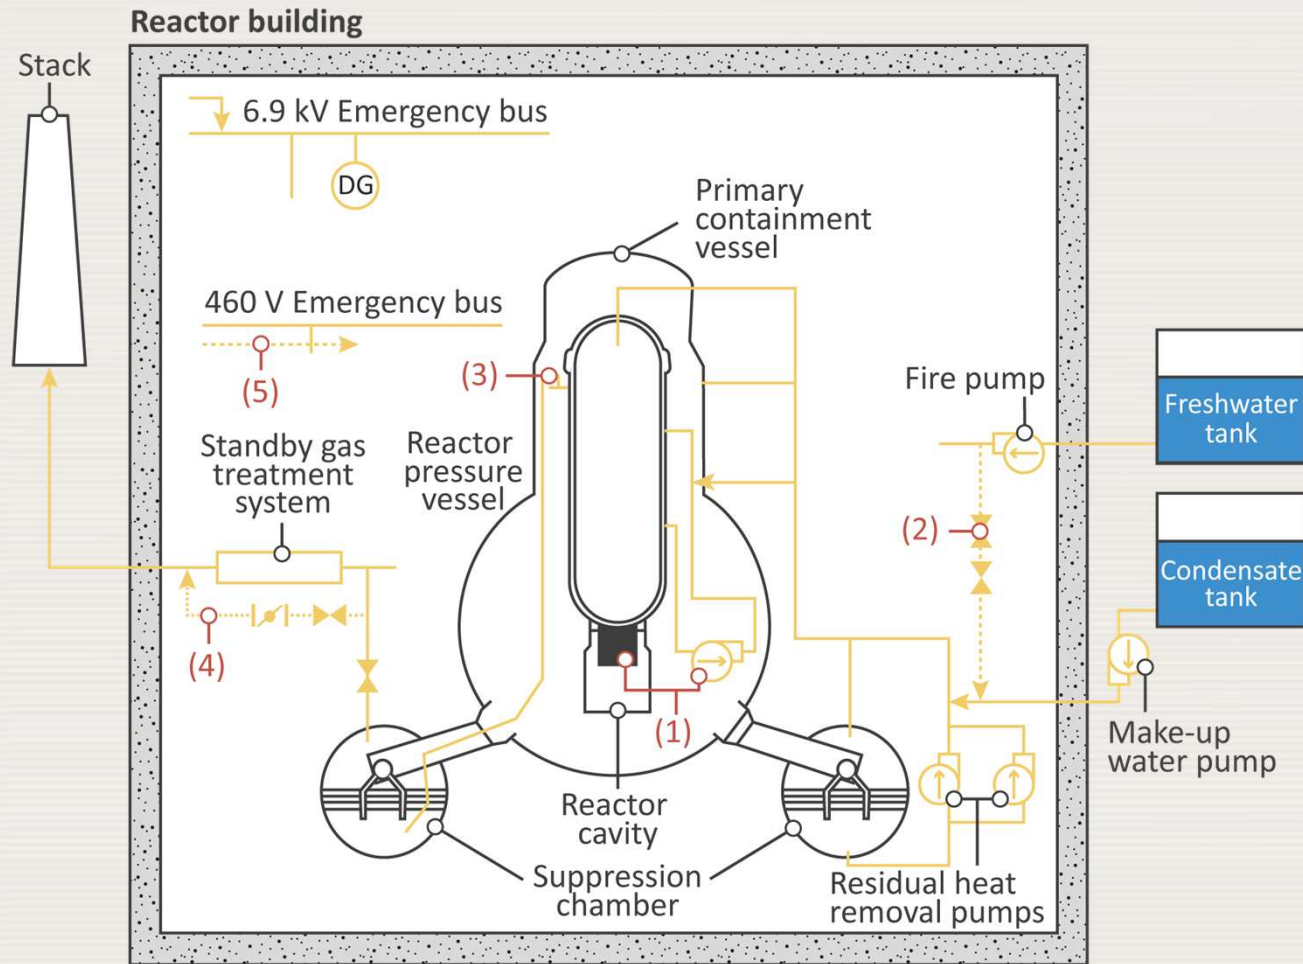
- **Severe Accident Management provisions in place at the Fukushima Daiichi NPP prior to the accident were not fully in line with international practice at the time**
 - Greater use of deterministic and probabilistic analyses for procedure development was needed
 - Training and strategies in the use of portable equipment was inadequate
- **Accident management guidance did not use the latest industry guidance**
 - Updated BWR Owners' Group generic guidance was not implemented at Fukushima Daiichi NPP

- **Accident management provisions need to be clear, comprehensive and well designed**
 - Training and exercises need to be based on **realistic** severe accident conditions.
 - **Time** is essential during accident response and having **clear and comprehensive instructions** saves time
- **Regulatory bodies need to ensure that adequate AM provisions are in place**
 - These requirements should consider **environment conditions**, adequacy of training and the availability and sufficiency of proper equipment
- **Provisions for the proper management of hydrogen need to be considered**
 - The hydrogen explosions during the accident were **unexpected** and negatively impacted the ability of operators to continue response activities

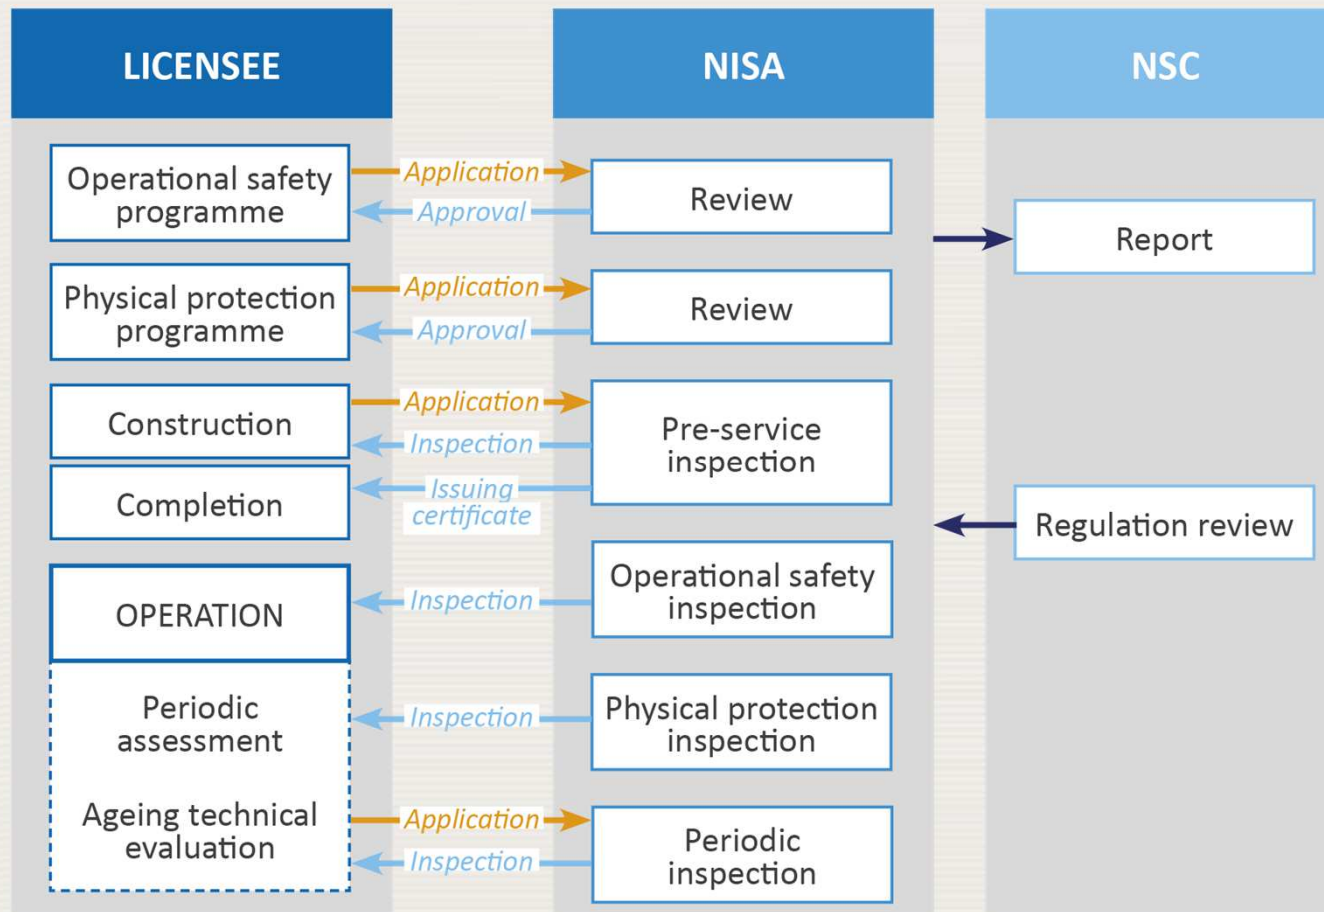
Regulatory inspection process for the operating stage of NPPs in March 2011

- **The regulatory system in place in Japan prior to the accident was complex and involved several different organizations**
 - The distribution of regulatory authority and decision making was **unclear**
- **Some regulatory practices in place prior to the accident were not on line with international best practices**
 - Inspection program was **overly limited in scope and influence**
 - Periodic safety reviews **lacked effective regulatory oversight**

- Where several bodies have responsibilities for safety, the government needs to **effectively coordinate** their regulatory functions.
 - **Clear lines of authority and decision making** ability so that all stakeholders understand the process
- The regulator should require that the operator of a facility **update** its safety demonstration on an ongoing basis to **reflect changes** in the status of the facility.
 - Regulatory authority needs the ability to **compel** the licensee to upgrade its facility
 - Regulator needs an **effective inspection program**
- Regulatory independence, competence, strong legislative authority and adequate resources, including qualified personnel, are essential
 - Regulatory authority needs **effective enforcement authority** and **access to independent technical expertise**

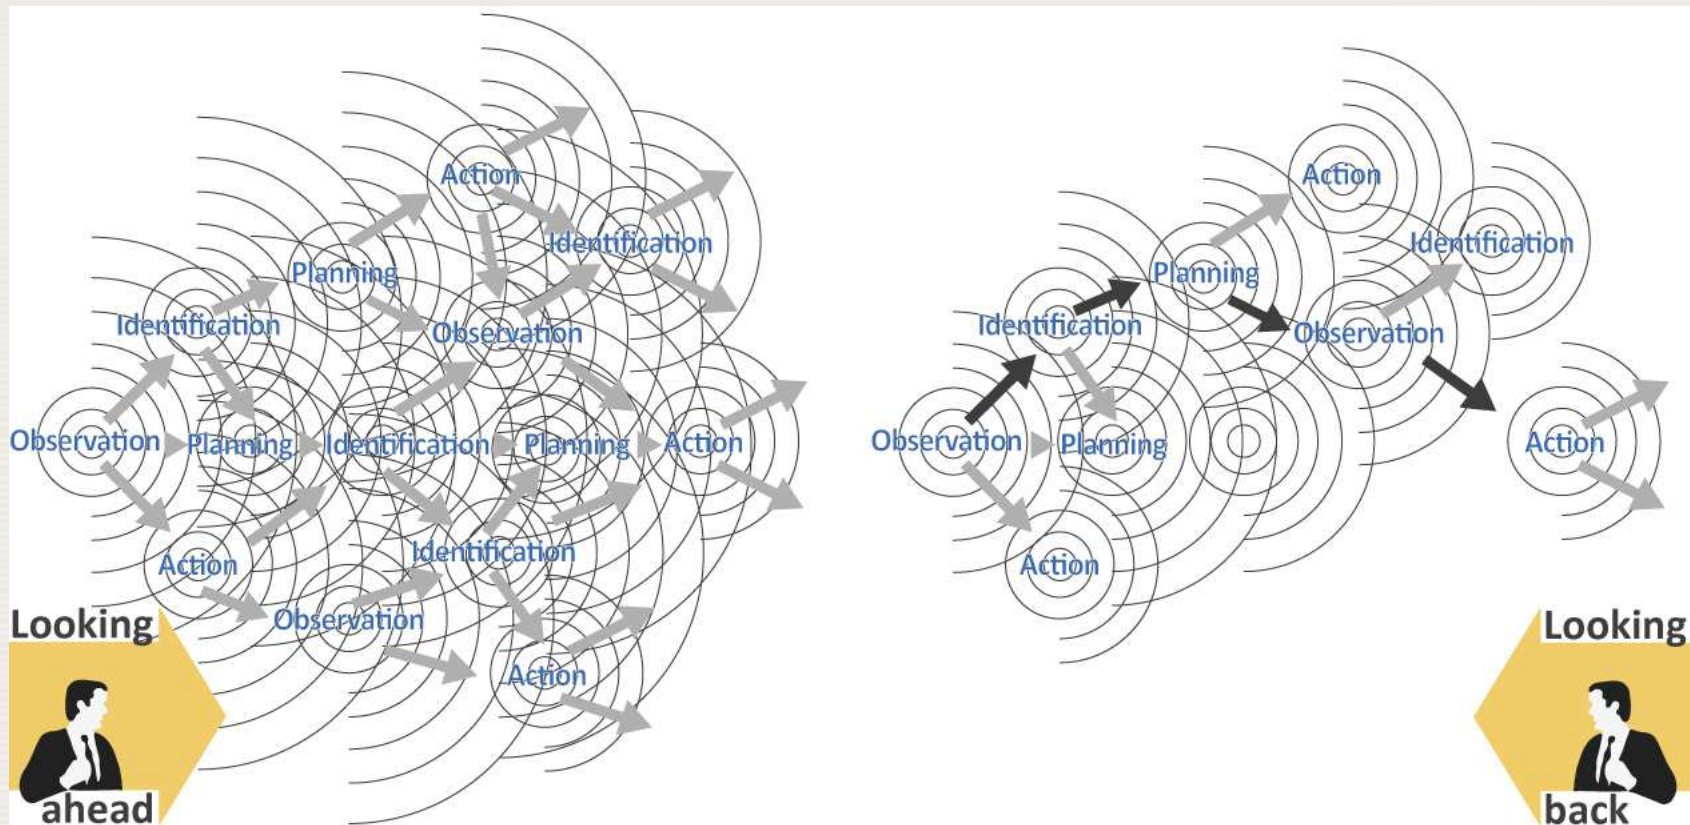
- **“Basic assumption” that plants were safe significantly contributed to the accident**
 - All stakeholders **shared and mutually reinforced** this belief
 - Influenced safety related decision making
- **Safety culture programs were unable to identify and correct this “basic assumption”**
 - Requires an **integrated approach** considering human, organizational and technical factors
 - For example, station blackout had been considered, but an **event of the magnitude that happened** at Fukushima Daiichi was **not** considered

- Individuals and organizations need to consciously and continuously **question their own basic assumption** and their implications on actions that impact nuclear safety.
 - The possibility of the **unexpected** should be considered
- Nuclear organizations need to **critically review** their approaches to emergency drills and exercises to ensure that they take due account of harsh complex conditions and unexpected situations.
 - **Better prepare first responders** with an understanding of what to expect during these types of postulated situations
